PENNSYLVANIA HISTORIC RESOURCE SURVEY FORM – PHOTO/SITE PLAN SHEET
Pennsylvania Historic and Museum Commission, Bureau of Historic Preservation
Commonwealth Keystone Building, 2nd Floor, 400 North Street, Harrisburg, PA 17108-1026

Survey Code / HR #:	66-049	Historic / Other Name:	Greystone Barn
Tax Parcel #:	66-4-19.5	Address:	609 Cricklewood Rd.
County:	Chester 029	Municipality:	Thornbury Township

PENNSYLVANIA HISTORIC RESOURCE SURVEY FORM – DATA SHEET

PENNSYLVANIA HISTORICAL RESOURCE SURVEY FORM – NARRATIVE SHEET 89C

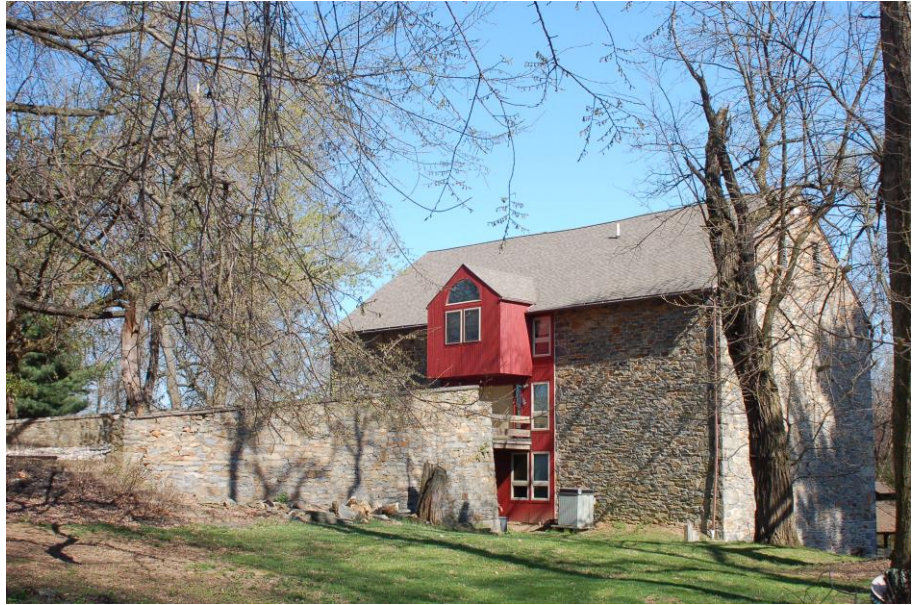
Photo 1. North (back) & West Elevations, House

The house at 609 Cricklewood Road is a three-bay, four-and-a-half-story, side-gable, stone and glass building. Its roof is clad in asphalt shingles. The fenestration is asymmetrical. This building was originally constructed as the barn for Greystone (HR #032). In the mid to late Twentieth Century, the barn was remodelled into a residence. As part of this process, the interior of the barn was gutted and an International-style glass and metal house was inserted within the barn's stone walls. This remodelling included the replacement of the barn's enclosed bridge with an open, wood foot bridge and a wood cantilevered bay.

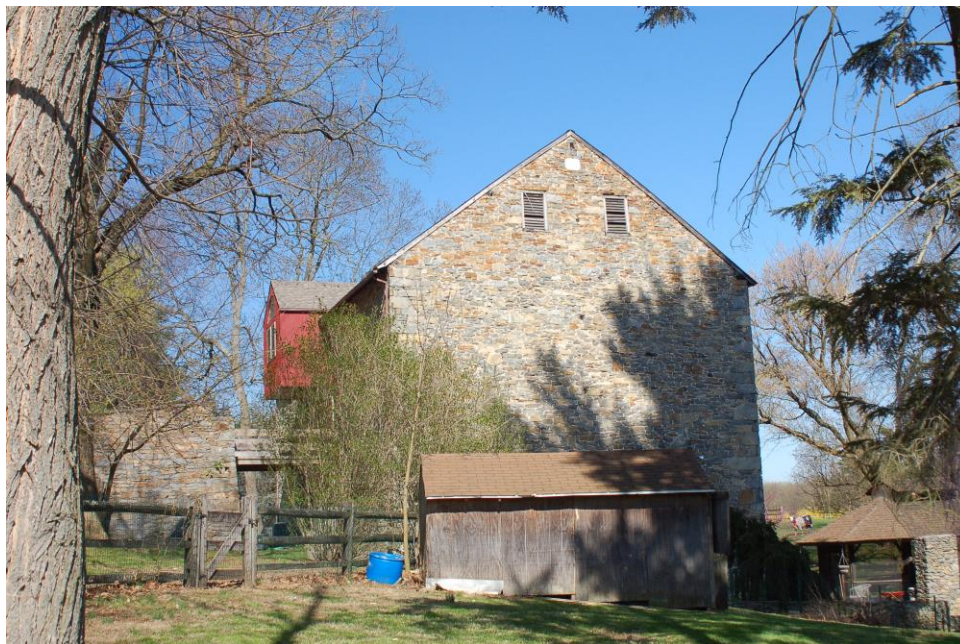
There is a small, one-story wood shed located immediately west of the house.

West Elevation, House, Showing Shed in Center Foreground
